Subject: Clean Water Act Compliance Evaluation Inspection Report

**CWA COMPLIANCE EVALUATION INSPECTION REPORT  
U.S. ENVIRONMENTAL PROTECTION AGENCY, REGION 5**

**Purpose:** Compliance Evaluation Inspection

**Facility:** Win Production, LLC  
Latitude: +39.614 Longitude: -90.508  
Lost Lane  
Winchester, Illinois 62694

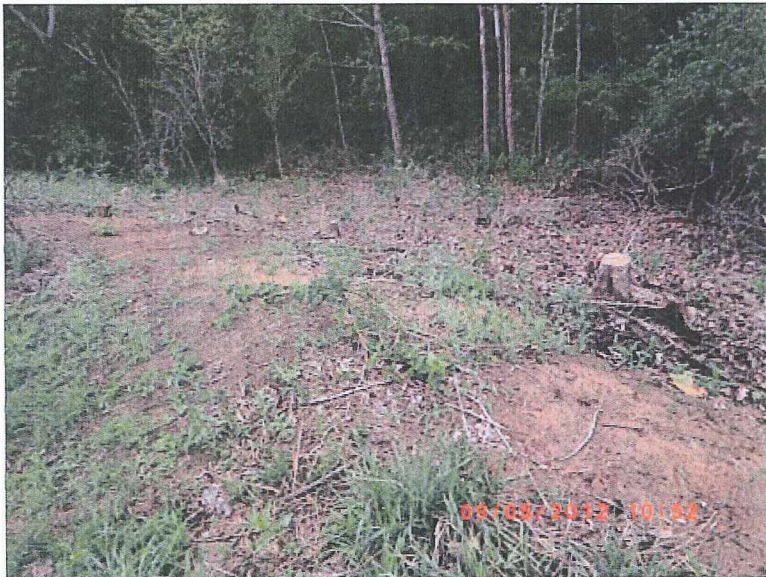
Starting at the entrance to the facility EPA proceeded north to P4. Woody growth had recently been cut down around P4's berms after suggestion by Mr. David Ginder during the 4/18/2012 IEPA inspection (IMGP0982). The berms appeared well maintained and the pond had sufficient levels of freeboard.

IMGP0982: Trees and shrubs located along P4 berms had been cut after recommendation by Mr. David Ginder during IEPA inspection.

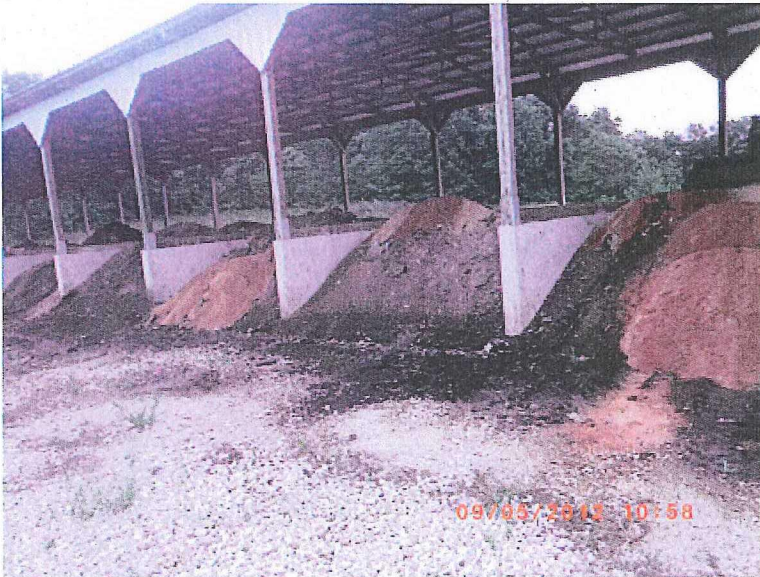
EPA continued north to the mortality compost shed. EPA observed compost solids and leachate around the immediate perimeter of the shed (IMGP0983, IMGP0984, and IMGP0985). Additionally, the mortality composting shed contained no gutters to facilitate the flow of stormwater. Stormwater could contact compost material around the perimeter of the shed. In the northwest corner of the shed was a ponded area (IMGP0986). The ponded area likely contained some compost process wastewater based on the color, foam, and proximity to the mortality compost shed.

IMGP0983: Compost had spilled onto perimeter of the mortality composting shed where it contacts stormwater.

4. Develop a system to measure levels in the waste holding ponds.
5. Maintain records of the levels and berm conditions in waste holding ponds.
6. Develop protocols to address clean water diversion and good housekeeping in and around the mortality composting shed.

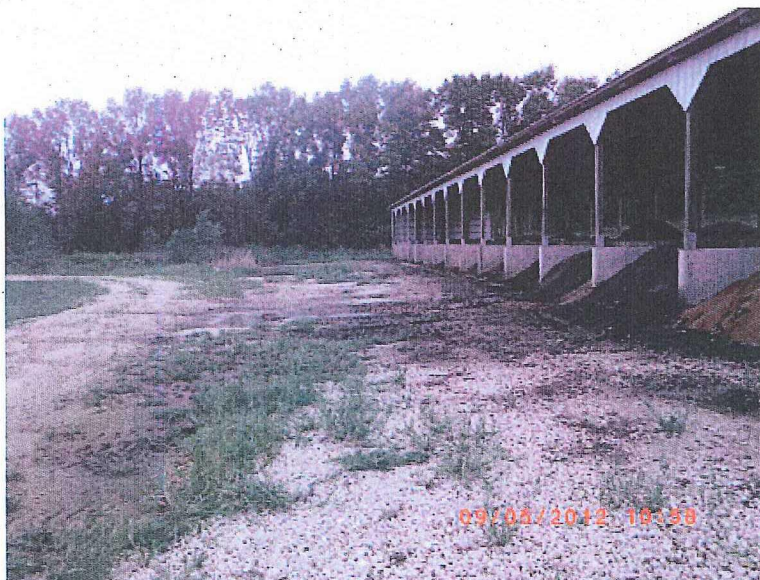
IMGP0984: Compost had spilled onto perimeter of the mortality composting shed where it contacts stormwater.

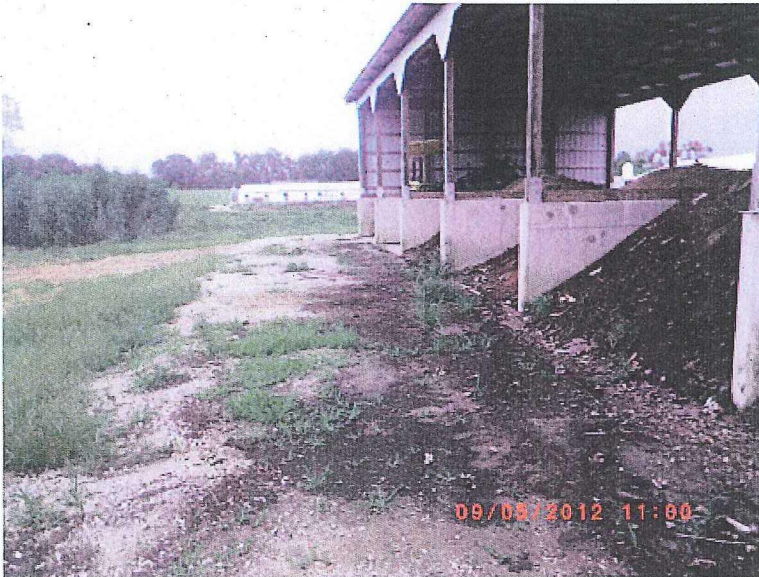
IMGP0985: Compost had spilled onto perimeter of the mortality composting shed where it contacts stormwater.

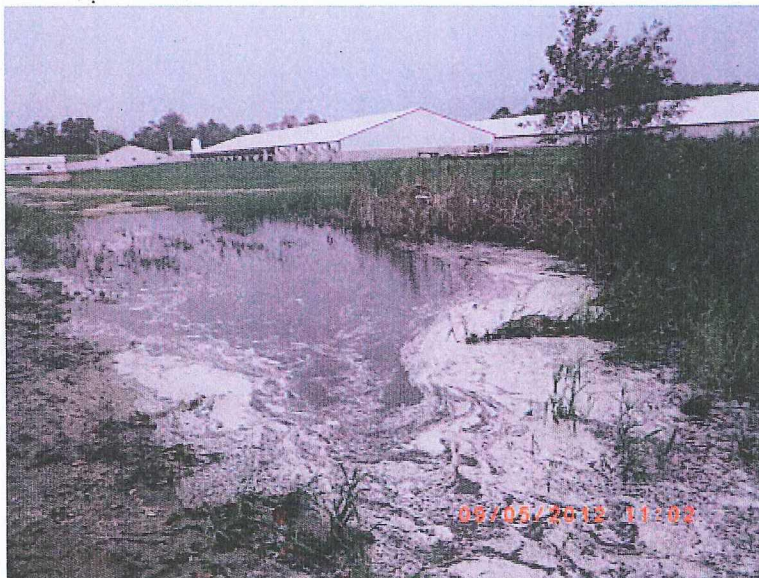
IMGP0986: Poned water near mortality composting shed. Poned water looked to contain compost nutrients.

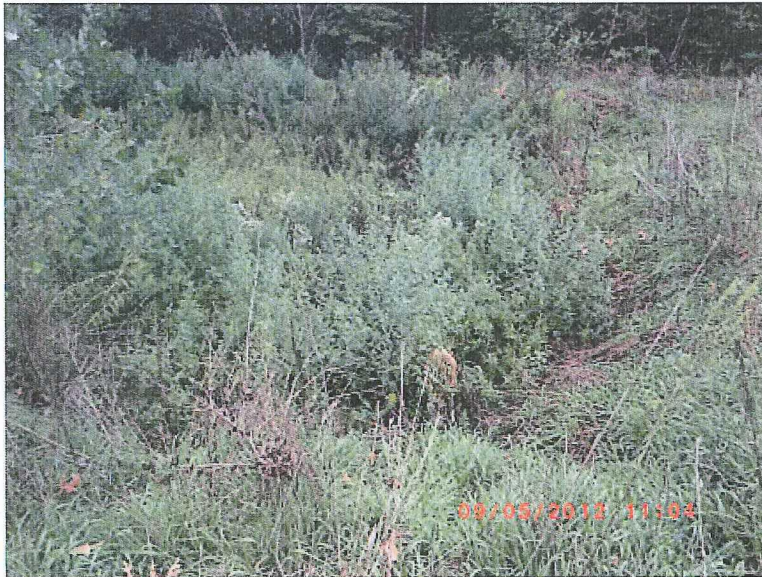
IMGP0987: A berm had been built around the north and west portion of the facility.

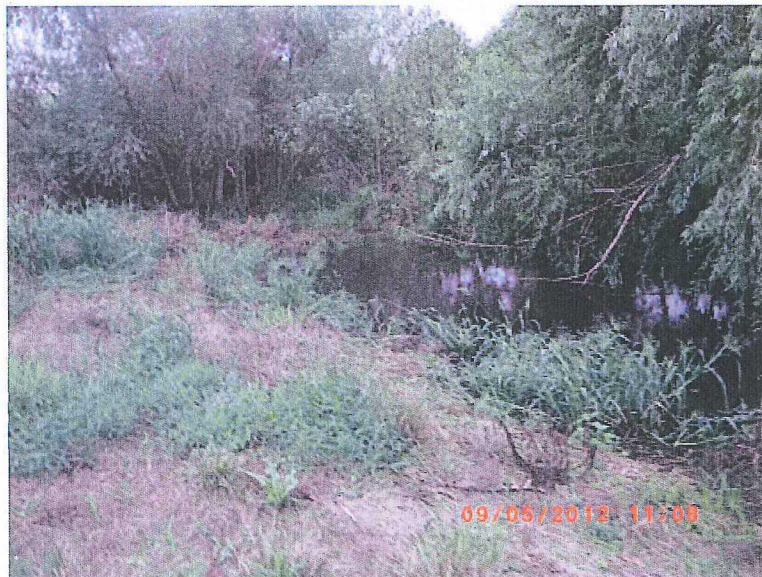
IMGP0988: Backside of berm around the facility contained water.

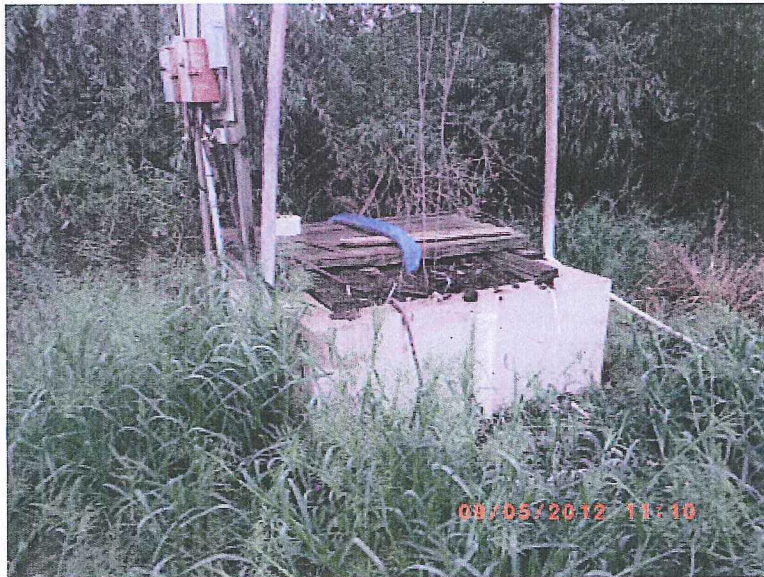
IMGP0989: Lift station that pumps manure from B3 and B4 to P1.  
Location: West side of B3  
Facing: West  
Date/Time: Wednesday, September 5, 2012, 11:10 am

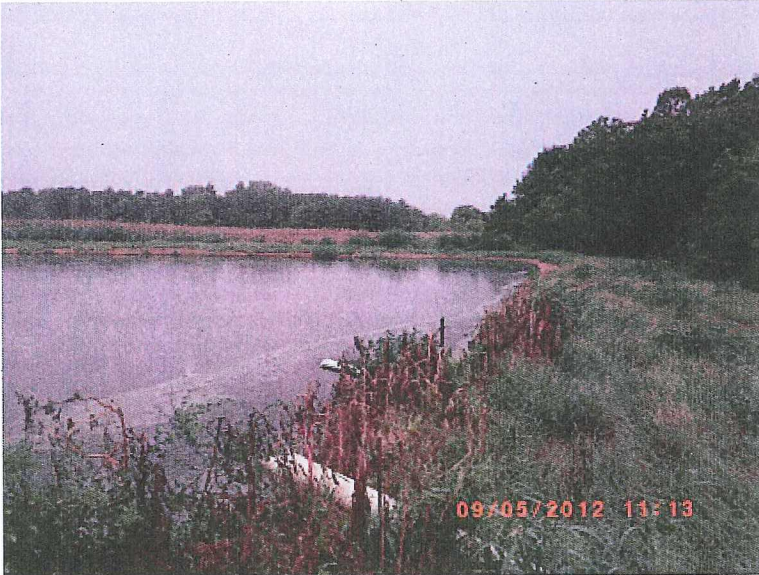
The north and west portion of the facility are surrounded by a berm. EPA walked along the berm and proceeded along the west end of the production area. EPA observed the lift station and then proceeded to P1 and P2. P1 did not have adequate free board. The berms of P1 and P2 were

IMGP0991: The northwest corner of P1 was the lowest in elevation. P1 did not contain sufficient freeboard. The NMP calls for a 2 ft freeboard and .6 ft of space to contain the 25 year 24 hour storm event.

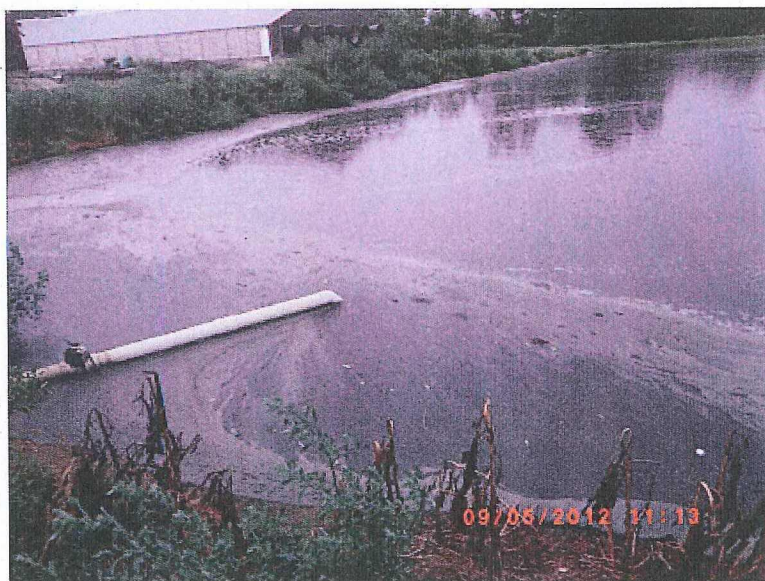
IMGP0992: The pumping station outlets into the northeast corner of the 1. The pumping station was running at the time of the inspection.

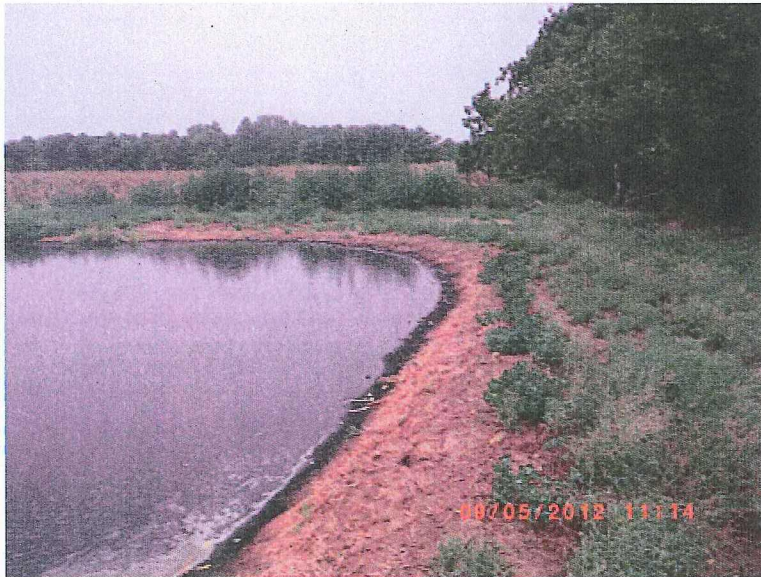
IMGP0993: The northwest corner of P1 was the lowest in elevation. P1 did not contain sufficient freeboard. The NMP calls for a 2 ft freeboard and .6 ft of space to contain the 25 year 24 hour storm event.

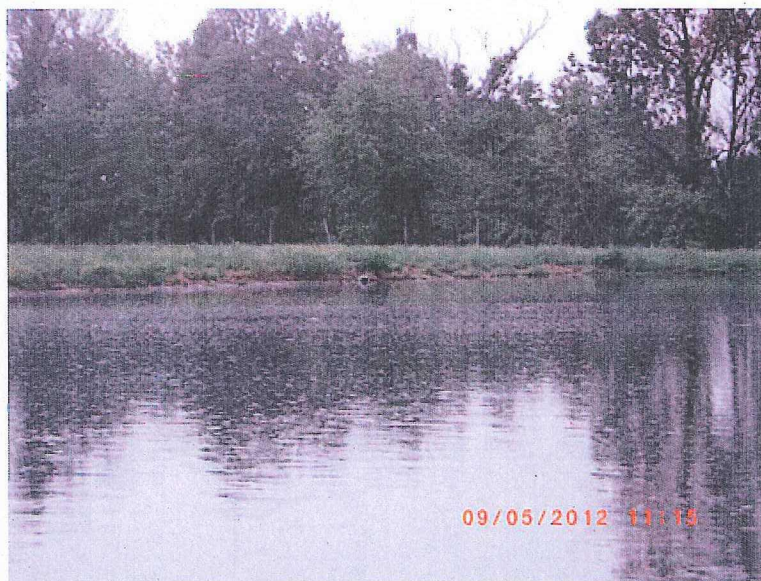
IMGP0994: P1 outlets to P2.

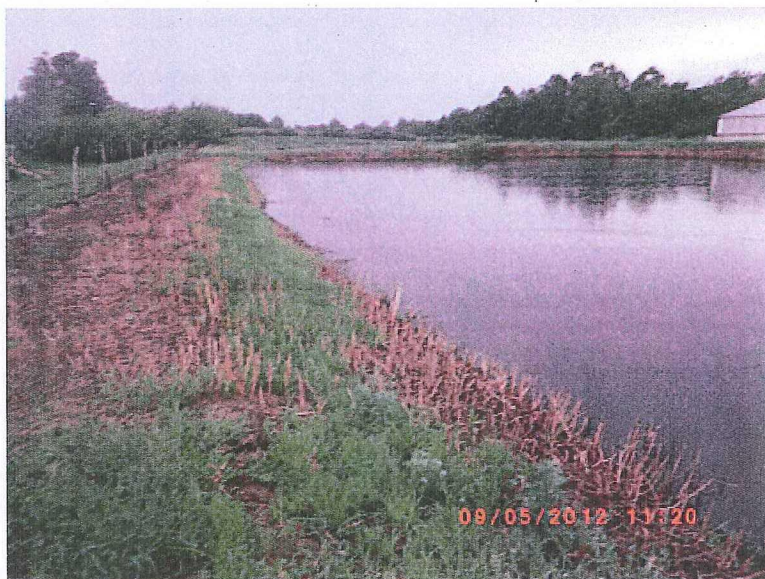
IMGP0997: P2

Location: Southwest side of the facility.

Facing: West

Date/Time: Wednesday, September 5, 2012, 11:20 am

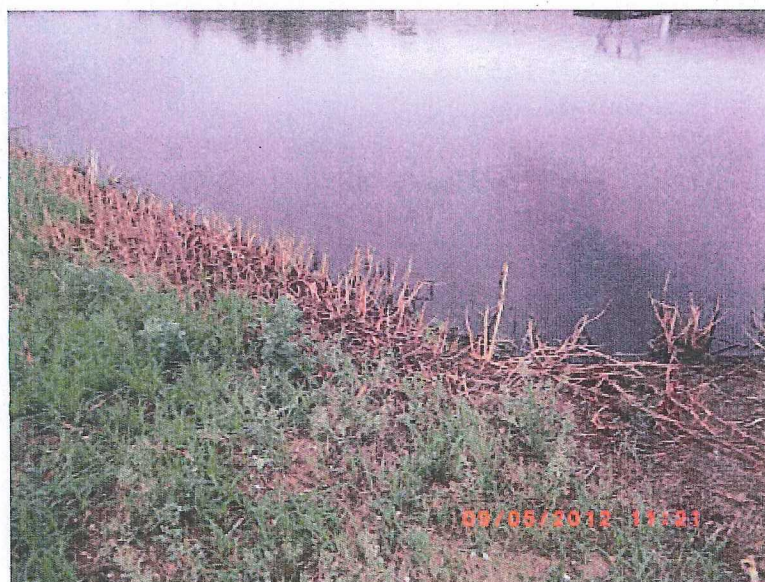
IMGP0998: P2

Location: Southwest side of the facility.

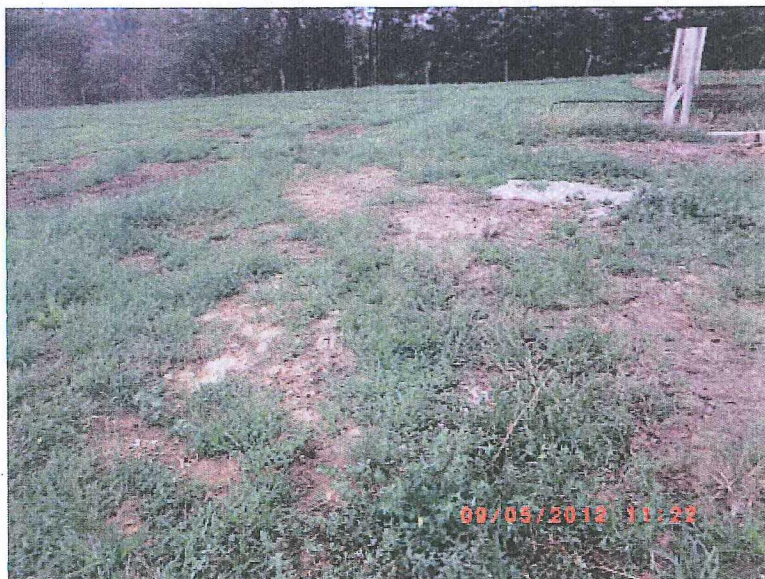
well maintained. Dumped feed was located in the area east of waste holding pond P2 (IMGP0999). EPA observed the bulk bins; no spilled feed was observed around the bulk bins. EPA continued to the entrance of the facility to conduct the exit briefing.

IMGP0999: There was some feed spilled to the east of P2.
